# U-Value Measurement for Building Standard Verification

greenTEG AG, Technoparkstrasse 1, 8005 Zürich

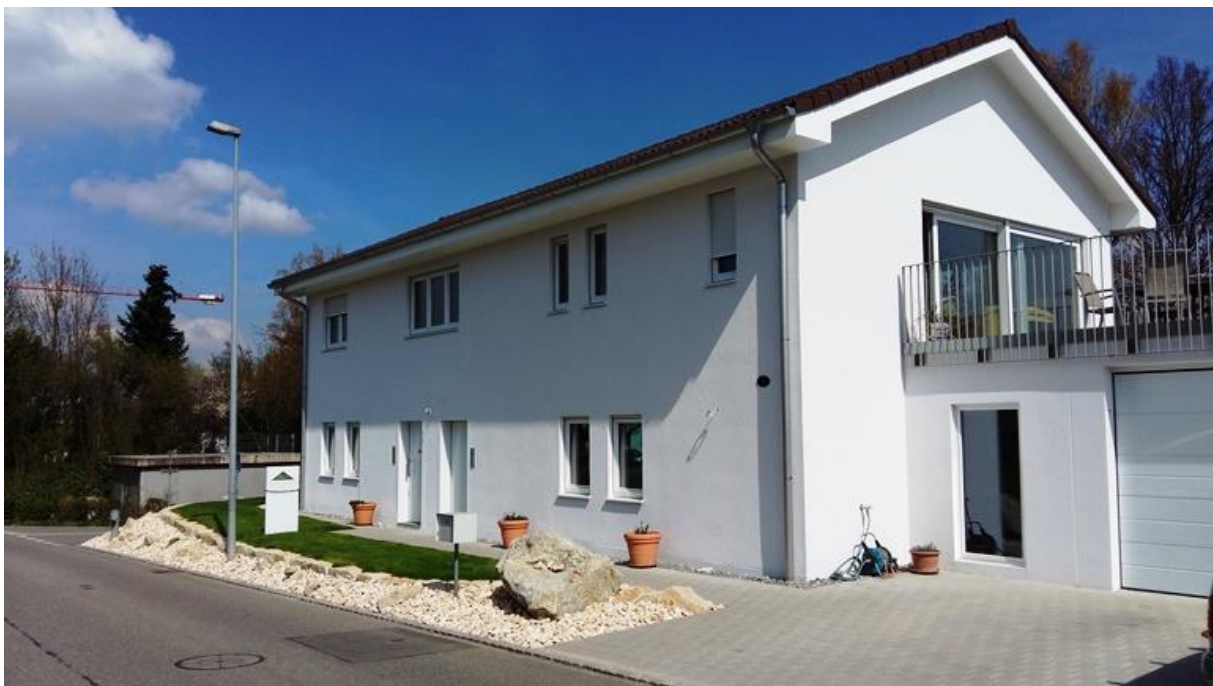
In Switzerland the so called *MINERGIE Standard* certifies buildings which fulfill very high energy-efficiency requirements. To reach the *MINERGIE Standard* a building must have a U-value of  $0.15 \text{ W}/(\text{m}^2\text{K})$  or below. This high standard is often met by using high-tech insulation materials which are expensive and need to be installed properly in order to take full effect. Unfortunately, this is not always the case and sometimes building contractors even use cheaper insulation materials than claimed. As a result, the required thermal insulation standard is not reached. In such cases it is difficult to prove sub-standard materials, without taking (drilled) core samples of the wall. The house presented in this study was suspected to have low quality

Figure 1 New constructed building at which the U-values had to be measured.

insulation material built in, because the construction firm went bankrupt and no detailed plans of the wall constructions were available. The local township insisted on a verification of the *MINERGIE Standard*, because the house was built in a commercial zone. Reliable estimations could not be performed due to the missing documentation, and core drillings would have damaged the new building. The *MINERGIE Standard* authority therefore commissioned a local building physicist and greenTEG to measure the U-value of various building elements. Because the greenTEG measurement device uses a highly sensitive heat flux sensor, it allows for accurate measurements even when having very low heat fluxes (e.g. high thermal insulation).

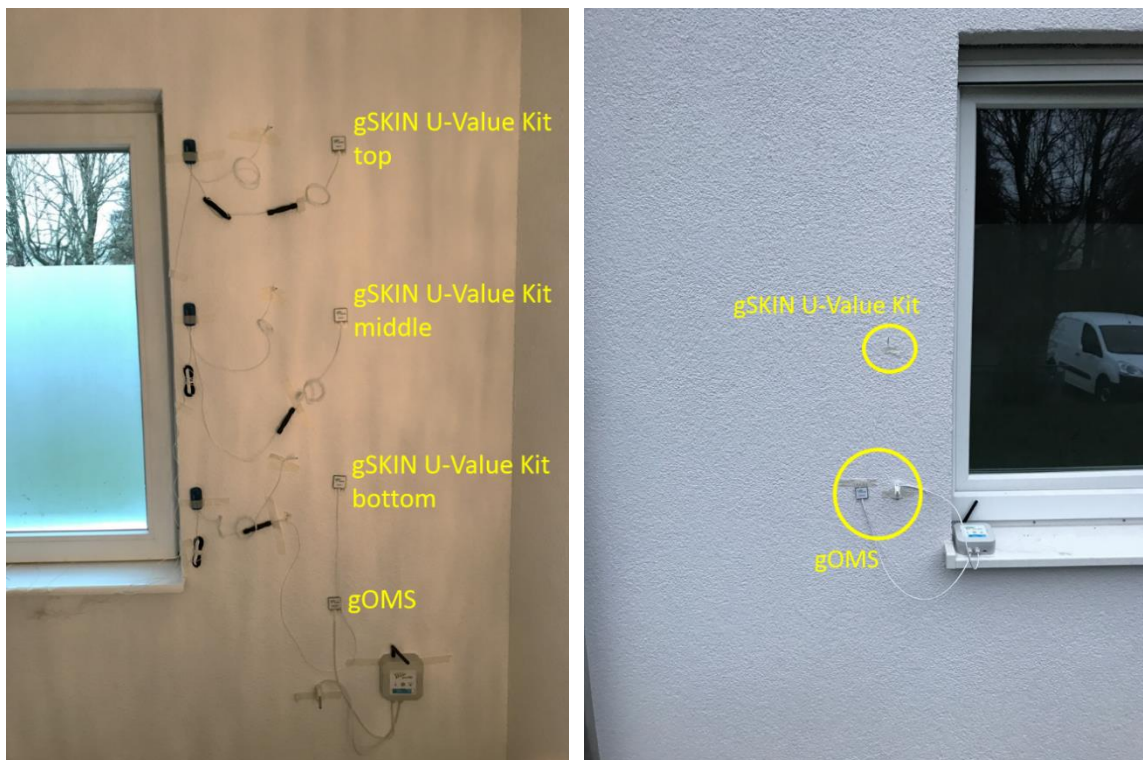
For the U-value measurements at the outer wall three measurements with the gSKIN U-Value Kit have been conducted right next to each other and a fourth one with the gO Measurement-System (gOMS) (see figure 2). All measurements were performed from the 08.12.2017 to the 11.12.2017.

Figure 2: Measurement set-up inside (left) and outside (right) at the outer wall

The inside and outside temperature sensors were placed directly opposite. The overall measurement period was 72h and all measurements completely fulfilled the ISO 9869 norm criteria. The results can be seen in table 1. In figure 3 the measurement curve of the bottom measurement point with the gSKIN U-Value Kit can be seen. The inside temperature was relatively constant over the entire measurement period and no significant irregularities in the heat flux can be observed. Furthermore, the measurements correspond very well with the estimations made by the building physicist and fulfill the *MINERGIE Standard* requirements, except for the topmost measurement point. The reason why the results for this point are higher than for the others can be explained through slight inhomogeneities of the wall or the

Measurement point	Measured U-Value	Estimated U-Value	Deviation
gSKIN U-Value Kit top	0.16 W/(m <sup>2</sup> K)	0.138 W/(m <sup>2</sup> K)	+16%
gSKIN U-Value Kit middle	0.13 W/(m <sup>2</sup> K)	0.138 W/(m <sup>2</sup> K)	-5%
gSKIN U-Value Kit bottom	0.14 W/(m <sup>2</sup> K)	0.138 W/(m <sup>2</sup> K)	+1%
gO Measurement-System	0.14 W/(m <sup>2</sup> K)	0.138 W/(m <sup>2</sup> K)	+1%

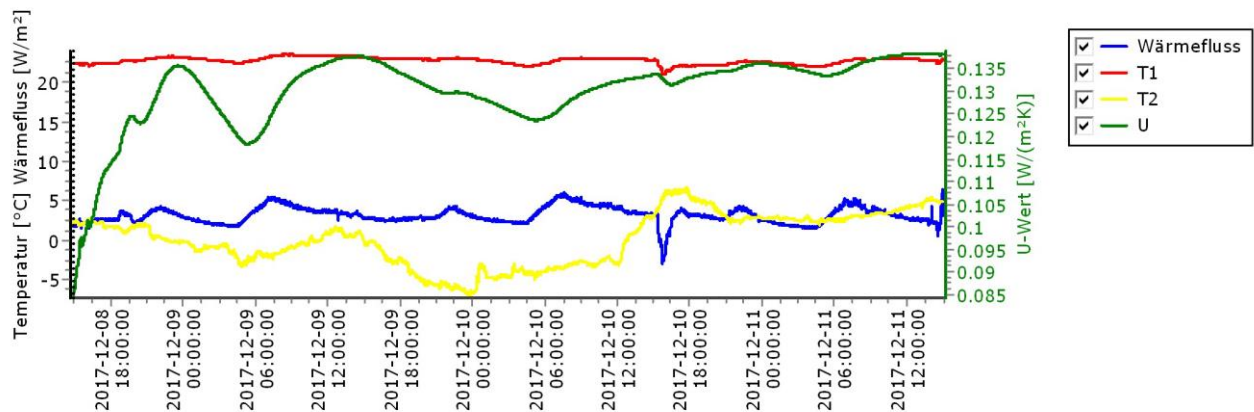
Figure 3 Measurement curve (bottom measurement) outer wall

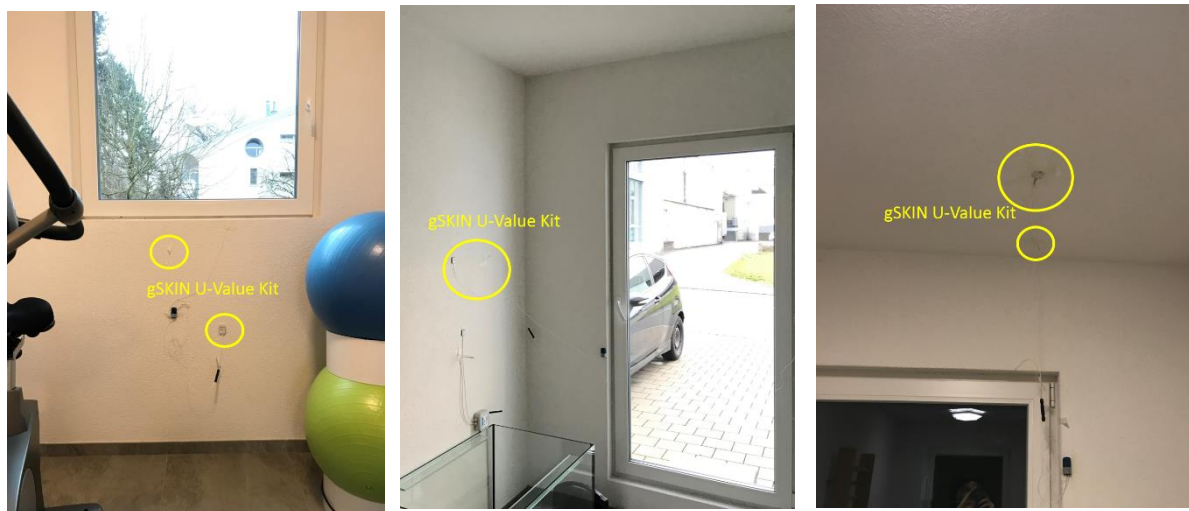
In the side room the U-value of the roof, outer wall and inner wall (adjacent to the garage) had to be measured (see figure 4). The first measurement period was between the 08.12.17 and 11.12.17. The measurement at the roof had to be repeated between the 11.12.17 and 14.12.27 due to heavy snow fall.

Figure 4 Measurements in the side room

Measurement point	Measured U-Value	Estimated Value	U-Value	Deviation
gSKIN U-Value Kit outer wall (8.12-11.12)	0.59 W/(m <sup>2</sup> K)	0.26 W/(m <sup>2</sup> K)		+127%
gSKIN U-Value Kit garage wall (8.12-11.12)	0.73 W/(m <sup>2</sup> K)	N.A.		N.A.
gSKIN U-Value Kit roof (11.12-14.12)	0.78 W/(m <sup>2</sup> K)	0.2 W/(m <sup>2</sup> K)		+290%

All results can be seen in table 3. As for the previous measurements at the roof, the estimated values differed significantly from the measured values. Apart from the measurement at the roof, the ISO 9869 conditions were fulfilled. The measurement at the roof did not fulfill the ISO 9869 requirements, because the outside temperature fluctuated heavily during the measurement period and the temperature sensor was exposed to direct sunlight in the morning of the 13.12.17 (see figure 5). Nevertheless, the measurement was not repeated, because the high heat flux clearly indicates that the U-value is too high and additional measurement would only have been time and cost-consuming, with no prospect for a U-value below  $0.15 \text{ W}/(\text{m}^2\text{K})$  (MINERGIE Standard)

Overall eleven U-values have been measured at a new building to verify the *MINERGIE Standard* requirements. All U-values, except for the U-value of the outer wall, were significantly too high to fulfill the requirements. Consequently, the insulation of the roof and the entire side room had to be improved in a costly refurbishment.

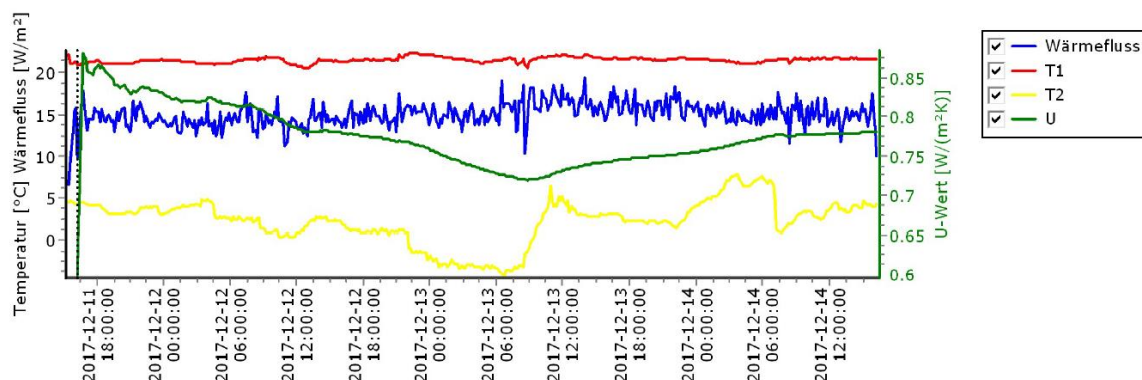
Figure 5 Measurement curve of the roof of the side room

The reason why some of the measurements did not fully fulfill the ISO 9869 conditions was mainly due to the difficult measurement conditions (sudden change in the weather, ranging from *föhn wind*<sup>2</sup> to heavy snow fall). For a highly accurate planning of the refurbishment the measurements at the roof of the side room would have had to be repeated.
